The River Adur

Knepp Estate

A Survey to Assess the Current Condition

Version 1.1 (May 2016)

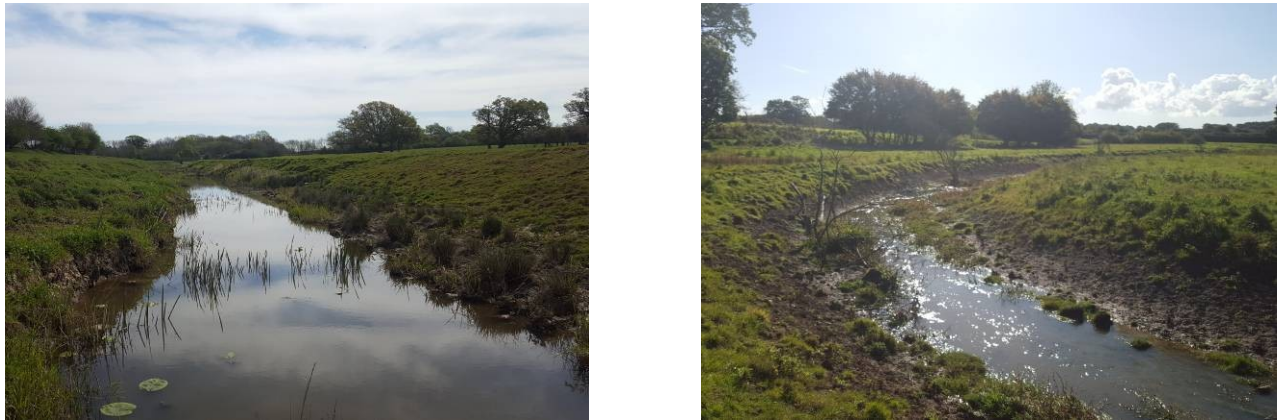
Across the survey area a total of three flow regimes were observed with 55% being recorded as having no perceptible flow, 32.5% as smooth and 12.5% as rippled (associated with glides) (Fig. 3). The number of flow regimes as an indication of diversity within each section is shown in Fig. 4. Only section one was recorded as having a >33% impoundment within it which is likely to be a result of the A24 bridge culvert and presence of Bay Bridge weir.

Fig. 3. Areas with no perceptible flow (left) and rippled flow (right) were both observed during the survey period.

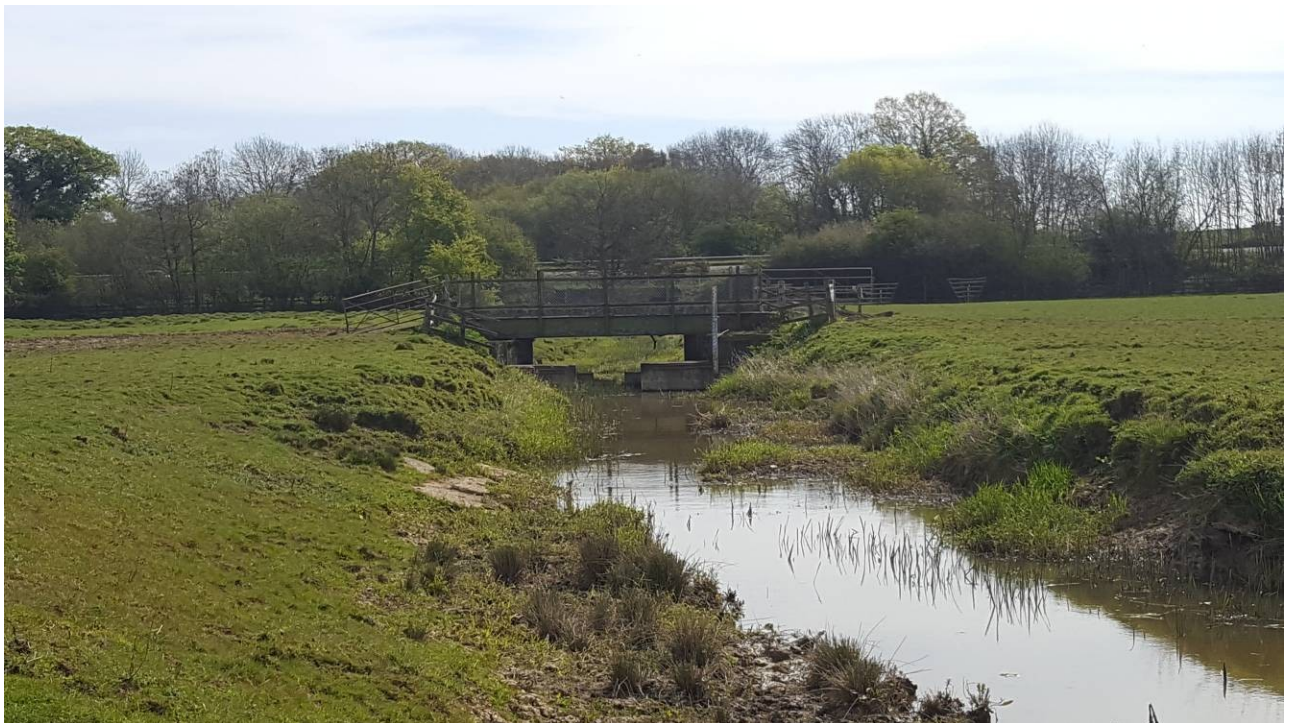
At the downstream extent of the survey area two modifications to the river system are present, the bridge culvert under the A24 and Bay Bridge Weir approximately 100m upstream (Fig. 5). At the time of survey the boards were removed from Bay Bridge Weir and in this state and from observation these are not preventing the movement of fish species within the survey area, however, should the boards be returned to the weir structure then coarse fish passage would be impeded during the majority of flow conditions. . The upstream section also recorded a culvert as the river passes under Capps Bridge but again this is not thought to be causing any barrier to fish passage (Fig. 6).

Fig. 5. Looking downstream to Bay Bridge Weir, one of three in-channel modifications on the River Adur through the survey area.

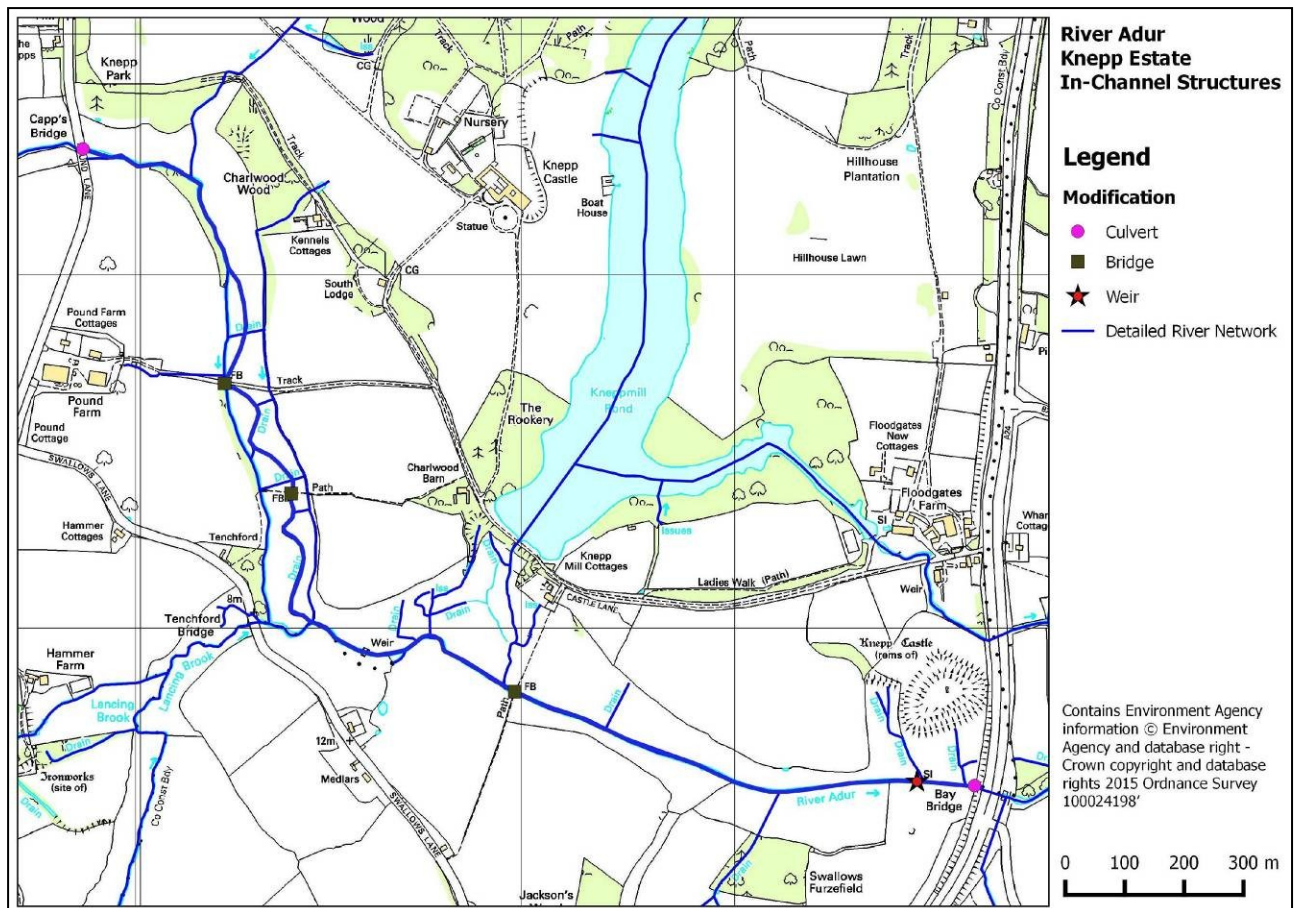
Fig.67. Locations of in-channel structures and bridges on the River Adur as it flows through the Knepp Estate.

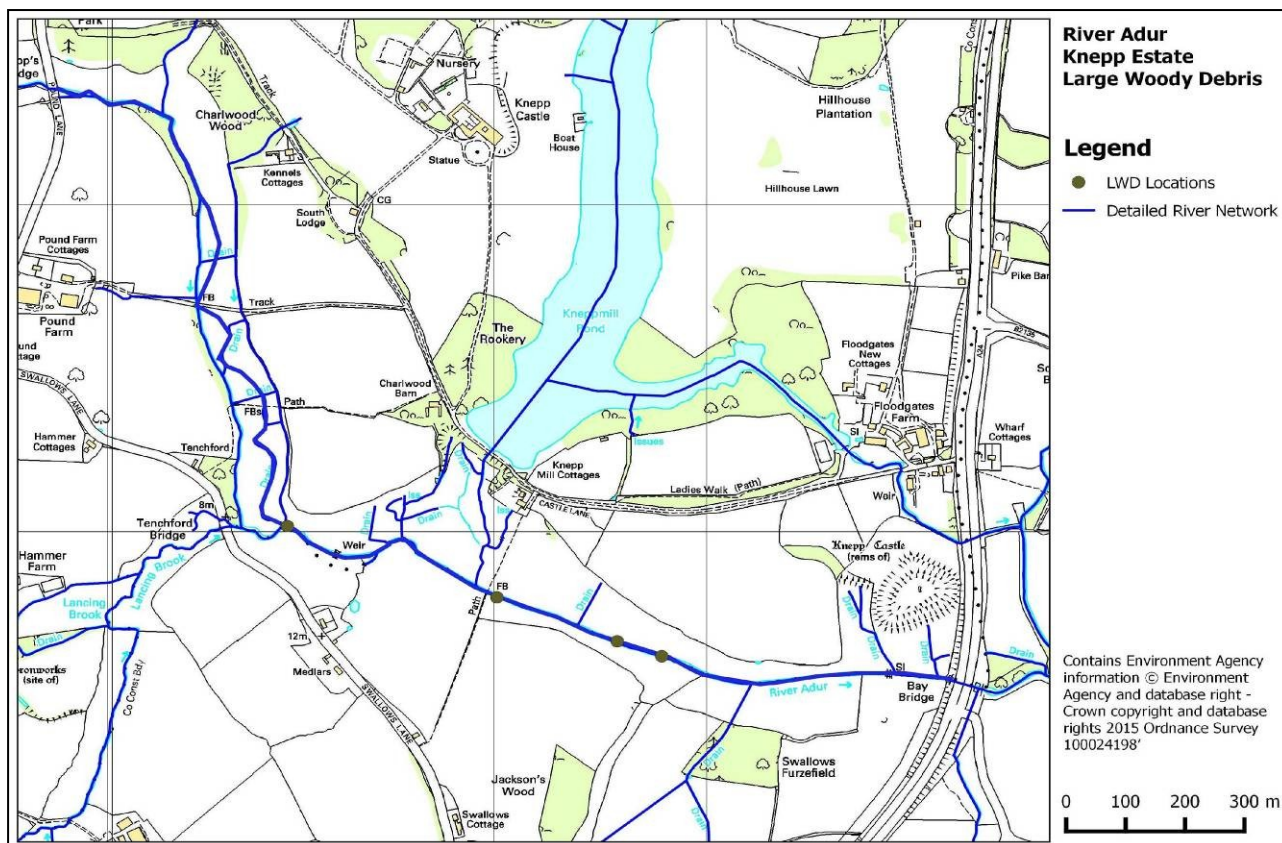
The highest number of features observed in any one survey section was 17 (sections 1 and 3). Whilst section three has been enhanced through the creation of a new channel and the introduction of a number of woody features, the features in section one appear to be occurring naturally through bank slumping as a result of the removal of the weir boards at Bay Bridge. Large woody debris was recorded at four locations along the length of the stream mainly concentrated in the central area (Fig. 8).

Fig. 8. Locations of large woody debris on the River Adur as it flows through the Knepp Estate.

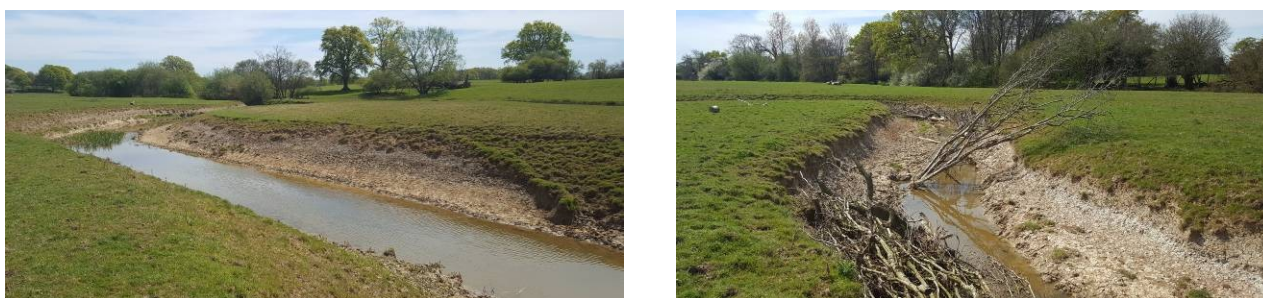
The dominant land use on both sides of the river is improved grassland for grazing which has, for the length of the survey, been enhanced to contain a number of scrapes as part of a wetland creation and floodplain connection project. Whilst some trees lined the banks on occasion there was no woodland cover on the land along the river corridor. By utilising the presence of certain vegetation types along the bank edge it is possible to infer which areas contain buffer strips. A >50% presence of one or a combination of the following vegetation types has been taken to represent an area which has a buffer of approximately 5m between the bank edge and the surrounding landscape: Broadleaf Woodland, Tall Herb/Rank Vegetation, Scrub/Shrubs, Wetland/Heath and Rough Unimproved Grassland. None of the survey area had suitable vegetated buffer strips to either bank although it is understood these are hard to establish as part of the wider project to re-wild the estate and allow livestock to roam free. All bank tops were recorded as having a uniform (1 plant community) vegetation structure which is in line with the absence of buffer strips along the river's edge (Fig. 10).

Fig. 10. Bare bank faces and uniform bank top vegetation structure dominate the River Adur through the Knepp Estate.

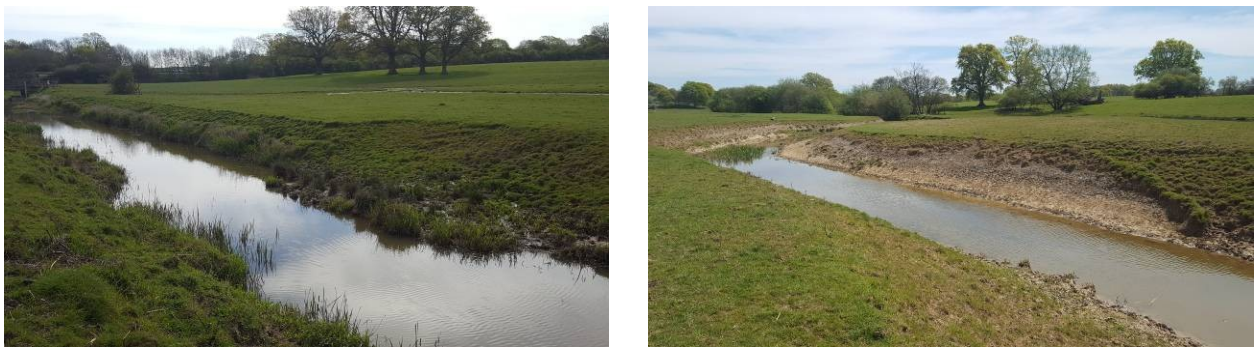
limited tree cover and the lack of riparian buffer strips are contributing to the relatively low habitat quality scores being realised along the course of the river. However, it is understood that the management regime of the landholding makes it difficult to create buffer strips or plant young trees without providing exclusion zones from livestock to allow trees to establish. However, the introduction of trees in the downstream sections would provide shading to the river along with natural recharge of woody debris, both important to the creation of a naturally functioning river system (Fig. 15). In addition bankside trees provide shelter for fish and invertebrates in exposed root systems and help to bind banks together, limiting any future increase in erosion risk. The establishment of buffer strips would also act as a filter to sources of pollution which would be washed into the river as flood water subsides (e.g. animal faeces).

Fig. 15. Bank side tree cover, buffer strips and in-channel vegetation establishment would all help in raising the habitat quality and ecological condition of the River Adur.

- Investigate the potential to introduce gravel substrate if historically present across the site.
- Introduce woody debris to more locations throughout the survey area, specifically within sections one, two and the upper reaches of section four.
- Establishment and enhancement of bankside and back face vegetation cover as well as strategic planting of trees would provide multiple benefits to the river and the species associated with it.
- Continue to monitor the river over time as further, natural enhancement is likely to occur within the channel

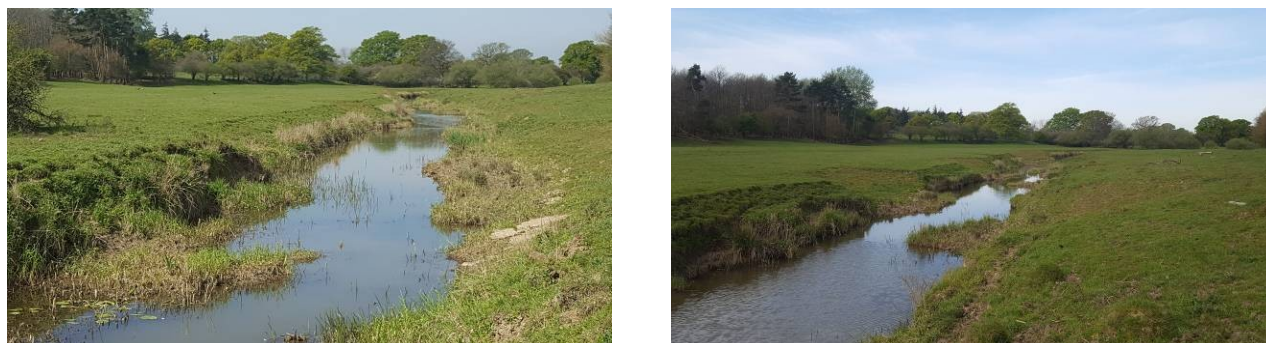
The observed flow diversity within the stream shows three different regimes of which rippled will be providing some oxygenation to the water whilst those areas with no perceptible flow will be adding to any silt loading which is occurring. However, this is likely to change over time as increased flow velocity as a result of the removal of weir structures should make the system more dynamic. There are no obviously impounded sections and those recording no perceptible flow are likely to be as a result of a lack of gradient within the river bed as it has levelled out through silt deposition when the structures were in place. All survey sections recorded the presence of in-channel features with sections one and three providing the highest number (17). Whilst section three has been enhanced through the placement of woody debris, section one is seeing the occurrence of natural bank slumping which is creating a series of berms, resulting in sinuosity and the establishment of in-channel, emergent, vegetation (Fig. 16).

Fig. 16. Section one of the survey area which appears to be re-naturalising as a result of the removal of the boards at Bay Bridge Weir. Bank slumping is creating berms and side bars which are adding to sinuosity and allowing emergent vegetation to establish.
