CNM30 Individual Project
In part fulfilment of requirements for the degree of
MEng (Hons) in Civil Engineering

**The Re-naturalisation of the River Adur on Knepp
Castle Estate**

May 2012

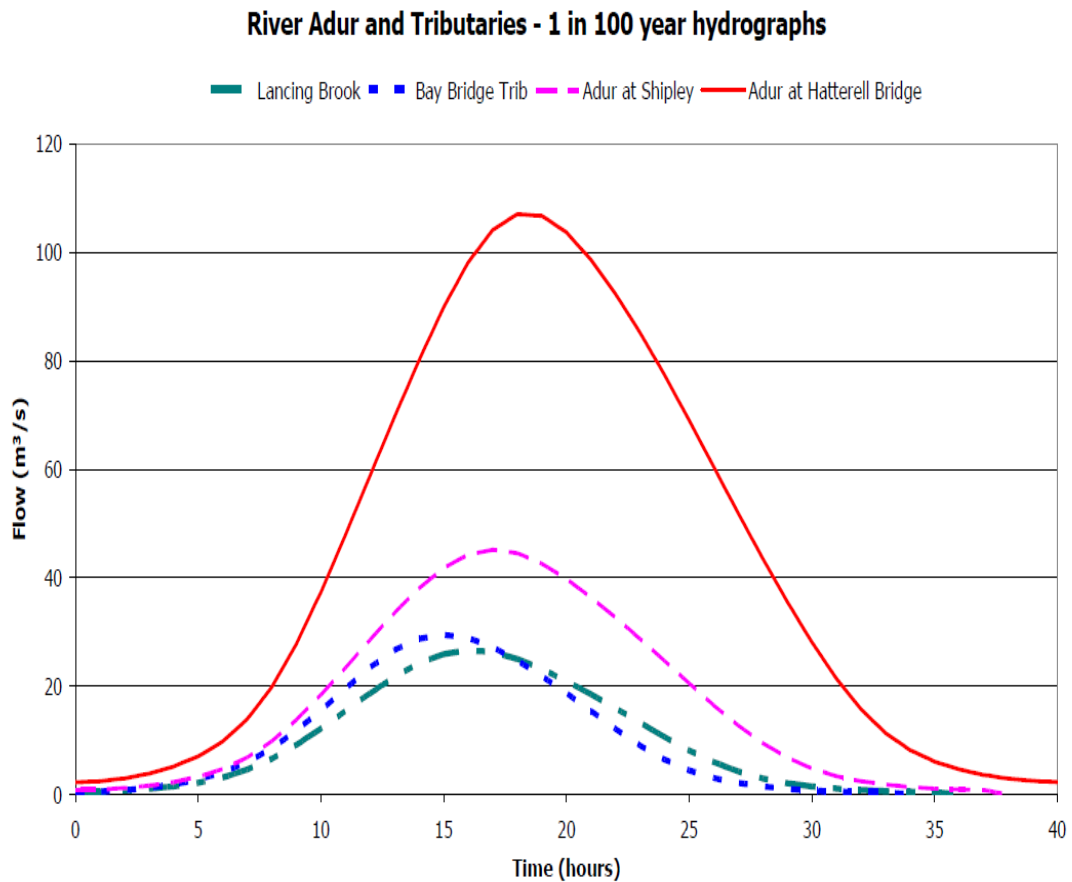
Figure 1: 1 in 100 year hydrograph for River Adur

Figure 1 shows how the flow in the different channels reacts in the event of a 1 in 100 year flood. The peaks of discharge are mostly seen between 15 and 20 hours after the event. The curves in each case are quite steep for the incline and this is also mirrored in the decline. This is caused by the geology of the area which is clay rich. This means there is little absorption of rain water into the ground but a lot of run-off that finds its way quickly into the river channels.

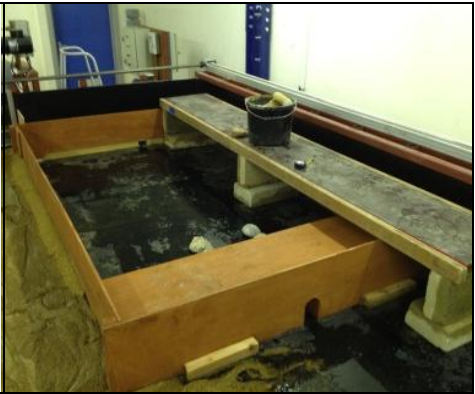
Canalised Channel – Setup	<ul style="list-style-type: none"> Enclosed space for channel construction approximately 2 x 1.5 metres Made from wood and treated with protective coating Platform put in place to allow access to all points of the channel model

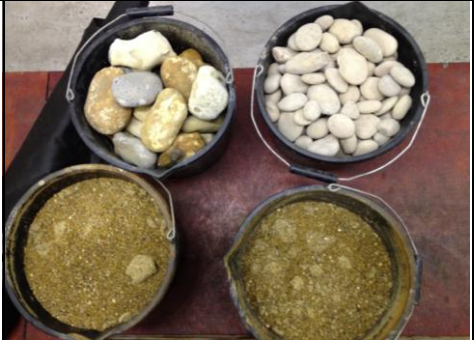
<ul style="list-style-type: none"> Different rock and sand sizes used for construction of the model

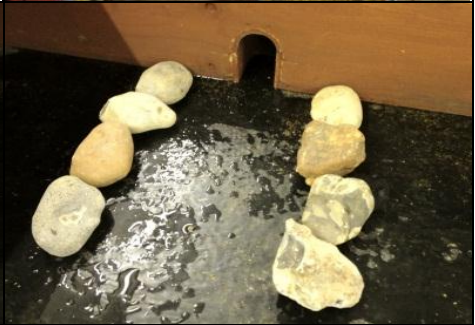
Canalised Channel – Setup	<ul style="list-style-type: none"> Larger stones used initially to construct the banks of the channel

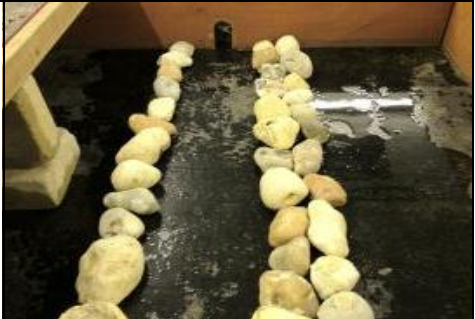
<ul style="list-style-type: none"> A second row of larger stones used to reinforce the foundation of the channel banks

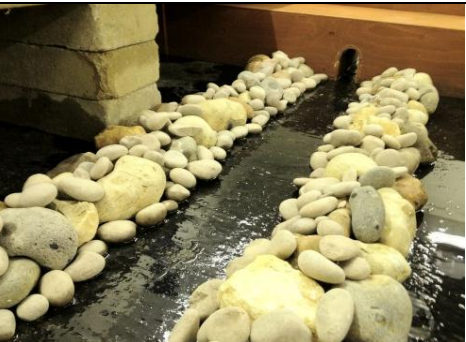
Canalised Channel – Setup	<ul style="list-style-type: none"> • Smaller stones added alongside the larger stones to further build up the foundations of the channel banks • Both banks covered with smaller stones to fill in gaps and strengthen

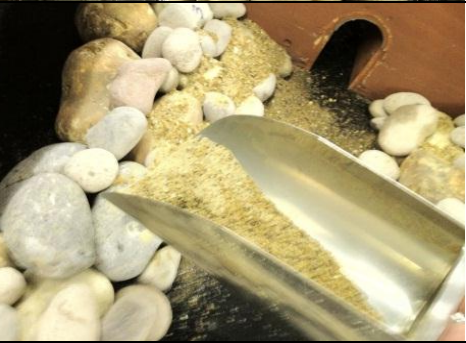
<ul style="list-style-type: none"> • Using a small handheld shovel, sand was poured onto the stones • The gaps were initially targeted to ensure a stable bank structure • Dry sand easy to pour into small spaces

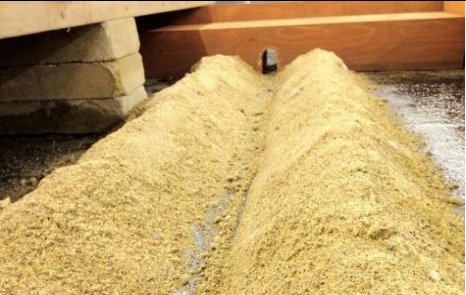
<ul style="list-style-type: none"> • The sand was made damp with water so it could be moulded to the desired dimensions • Using a trowel and small pieces of wood, the channel was moulded to meet the required dimensions • 8cm base and 4cm depth

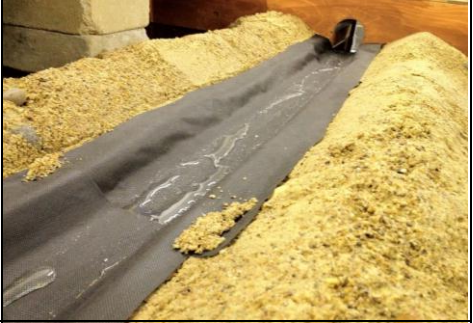
<ul style="list-style-type: none"> • Geotextile cut to fit the channel and banks

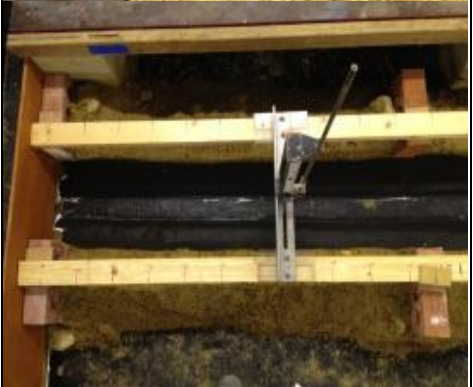
<ul style="list-style-type: none"> • Bricks added into the banks structure but not altering the channel design • Two pieces of wood positioned as runners for the point gauge • Marks made at 10cm intervals for depth readings the be taken

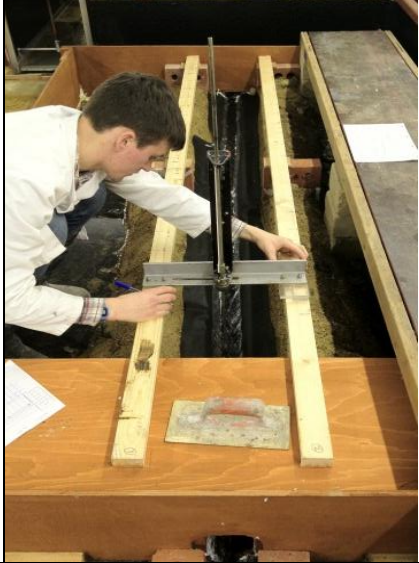
<p>Taking readings</p>	<ul style="list-style-type: none"> • Readings taken for depth at 10cm intervals starting from the culvert back upstream • Point guage able to give readings in terms of milemetres • Fine adjustment component on point guage allowed measurements to be taken at exact point of contact with water surface

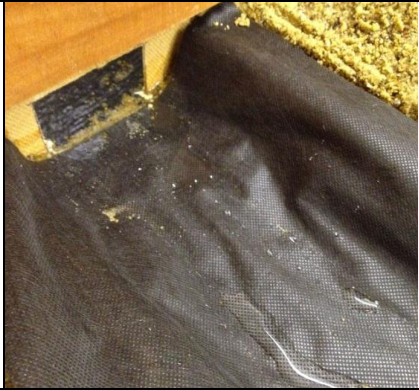
<p>Observations made</p>	<ul style="list-style-type: none"> • As the geotextile was cut as one piece to fit the entire channel it allowed water to pass underneath • Difficult to ensure that all the water was flowing on top of the geotextile surface

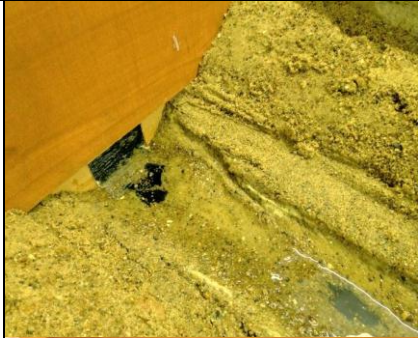
<ul style="list-style-type: none"> • Removal of geotextile revealed the erosion of the banks that took place • This was caused by water flowing underneath the geotextile • Banks not keeping their initial profile

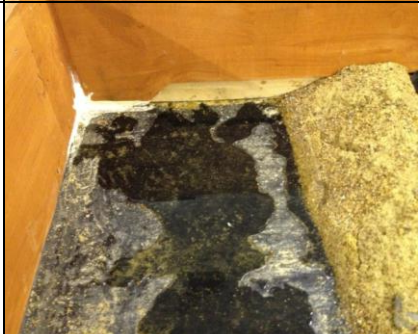
Observations made	<ul style="list-style-type: none"> • Water flowing through culvert model • The culvert section did not sit in complete contact with the floor and water was able to flow underneath • Not showing an accurate picture of water interaction in a culvert

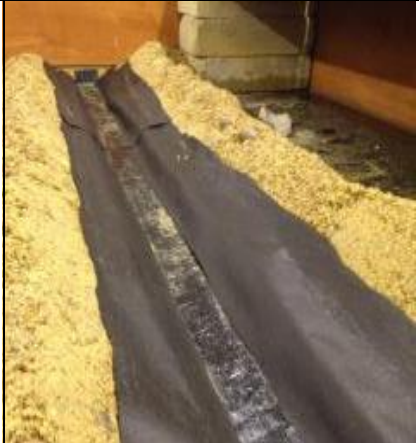
Improvements made	<ul style="list-style-type: none"> • Geotextile now cut into two separate pieces for each bank • No geotextile on base surface to prevent water from flowing underneath • Edge of geotextile fixed to the channel surface with silicone sealant

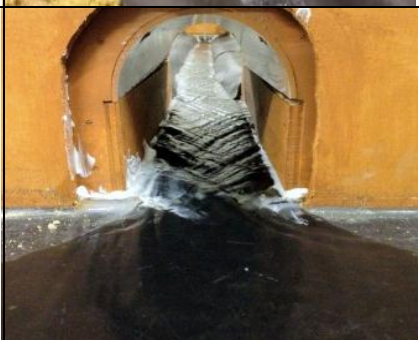
Improvements made	<ul style="list-style-type: none"> • Silicone sealant used to seal the culvert section to the base surface • Water now unable to flow underneath giving a more realistic water behaviour in the culvert model

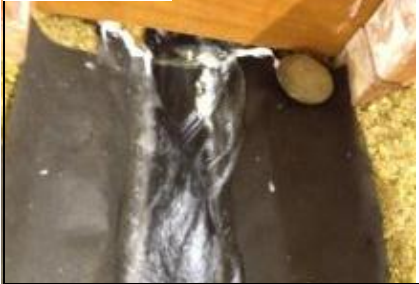
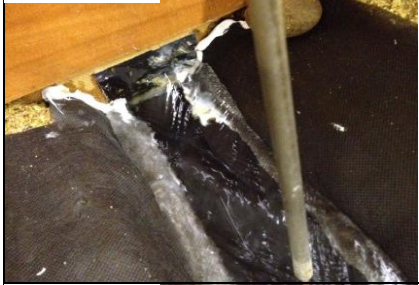
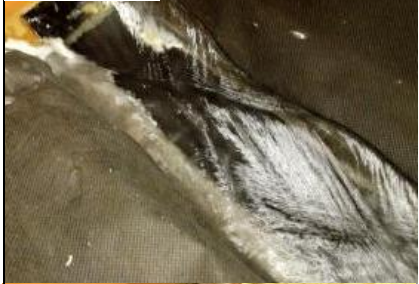
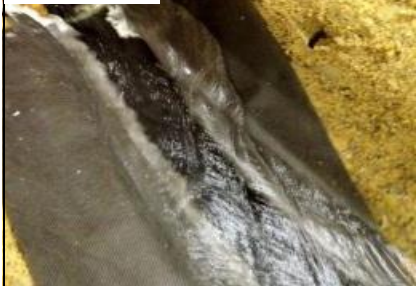
Channel inlet	<ul style="list-style-type: none"> • The pictures show an increase in turbulence as the discharge was increased • The small pebble was washed away by the force of the water in Scenario 3 and 4 • The geotextile was eventually undermined in Scenario 4 	<div data-bbox="997 230 1417 568"> <p>Scenario 1</p>

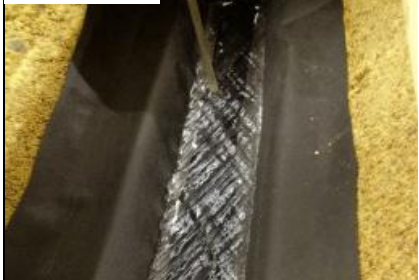
</div>
Culvert inlet	<ul style="list-style-type: none"> • The depth at the culvert inlet increased with greater discharge • Free-surface flow upon entering the culvert as seen in Table 2 • The water became more turbulent 	<div data-bbox="997 1585 1417 1919"> <p>Scenario 1</p>

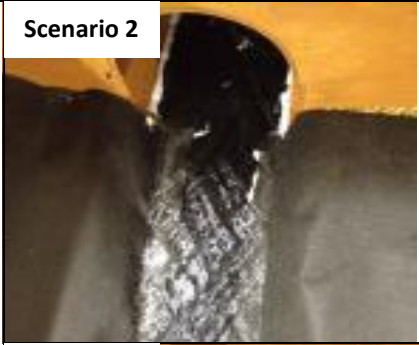
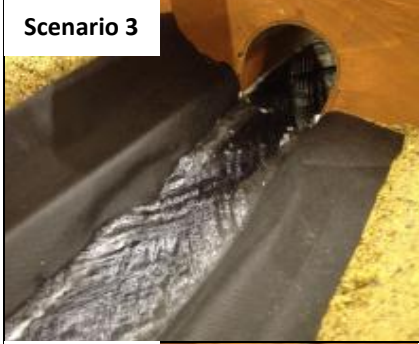
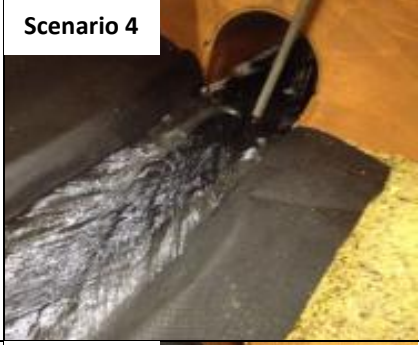
<ul style="list-style-type: none"> For Scenario 3 and 4 it can be seen that the banks of the channel had started to erode beneath the geotextile 	<p>Scenario 2</p>

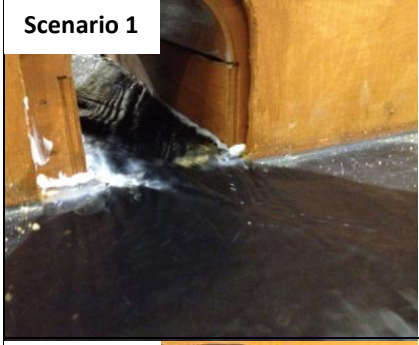
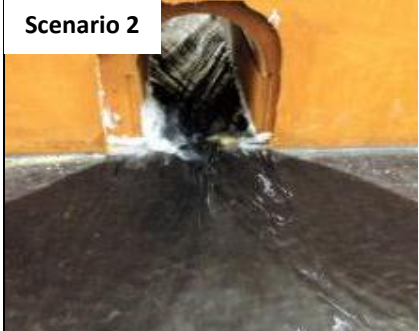
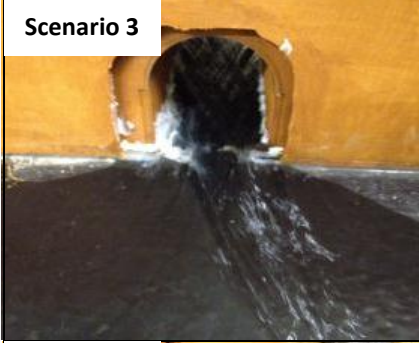
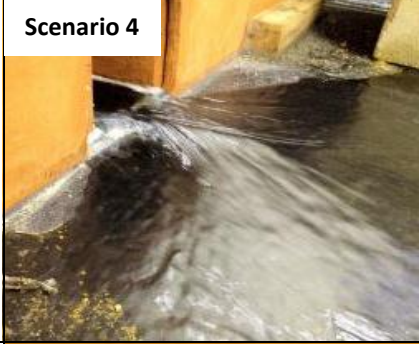
Culvert outfall	<ul style="list-style-type: none"> As the discharge increased so too did the turbulence of the water in the culvert The water came out with increasing force For Scenario 4 the depth of the water was visibly higher as it left the culvert No hydraulic jump present and so the flow was outlet controlled according to Table 2 	<p>Scenario 1</p>

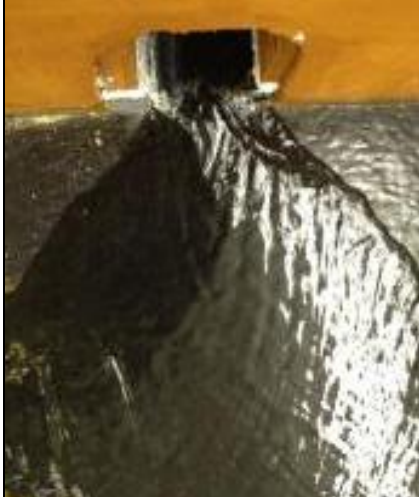
</div>
<p>Observations made</p>	<ul style="list-style-type: none"> • The picture shows the shape of the water dispersal upon leaving the culvert • This is not a true reflection of the culvert in real life as the channel would continue afterwards and this would affect the behaviour of the water

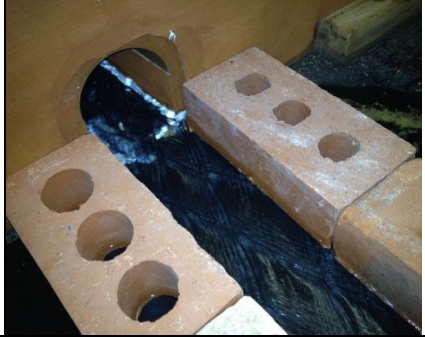
Improvements made	<ul style="list-style-type: none"> • Bricks added at the outfall of the culvert to create a channel profile • This caused the water to behave in a more realistic way when passing through the culvert

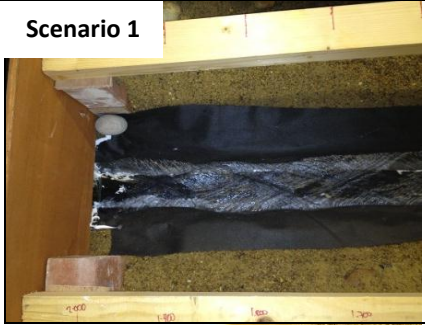
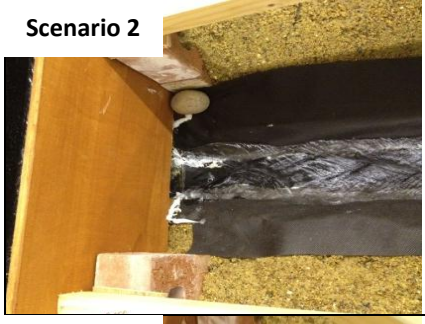
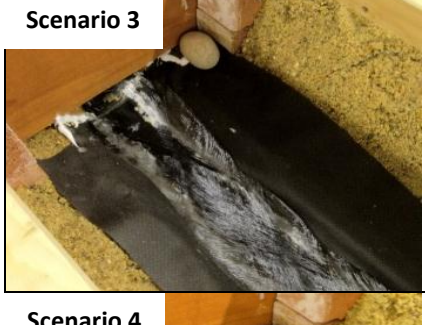
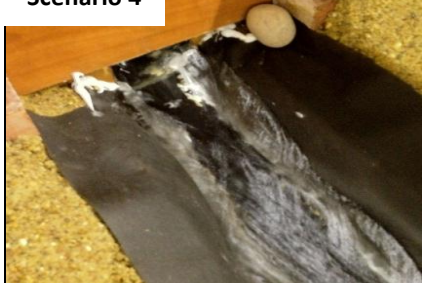
Channel inlet	<ul style="list-style-type: none"> • The depth of the water entering the channel was higher with greater discharge • The turbulence of the water also increased • The profile of the embankment was slightly eroded with the increasing discharge 	<div data-bbox="991 741 1417 1064"> <p>Scenario 1</p>

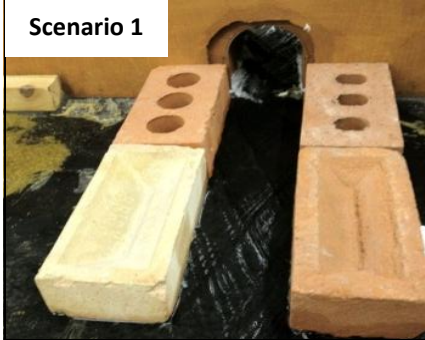
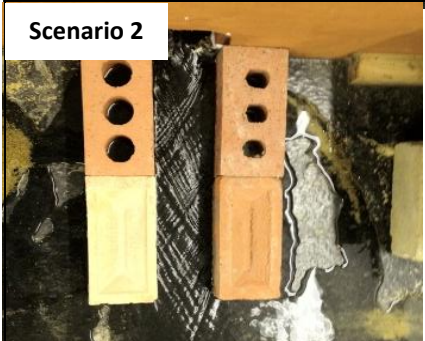
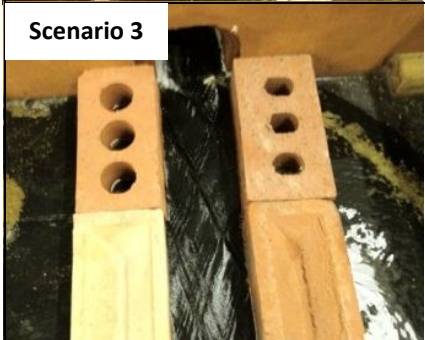
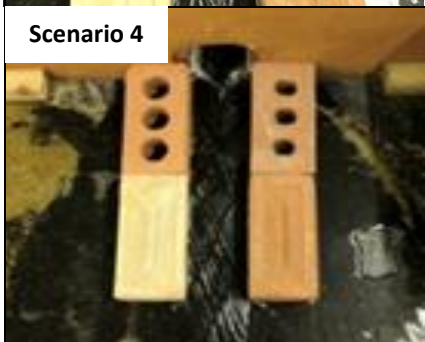
<p style="writing-mode: vertical-rl; transform: rotate(180deg);">Culvert outfall</p>	<ul style="list-style-type: none"> • The speed and force at which the water left the culvert increased with greater discharge • The turbulence was also made greater as the discharge increased • Outlet controlled flow and no hydraulic jump occurred 	<div data-bbox="991 230 1417 568"> <p>Scenario 1</p>

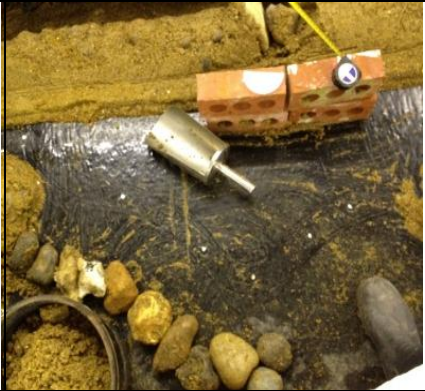
Meandering Channel – Set up	<ul style="list-style-type: none"> • Tape measure and protractor used to mark out the shape of the meander • Mid-section of channel removed for meander construction • Larger stones used to form foundations of new embankments

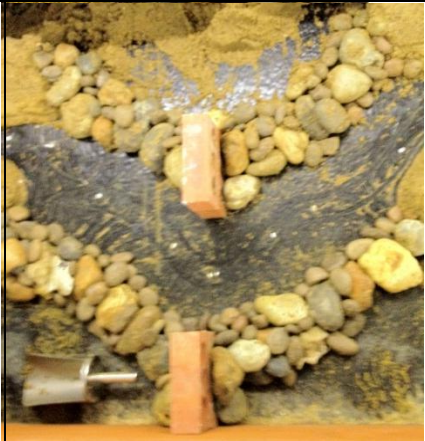
<ul style="list-style-type: none"> • Bricks put in place within the embankment to provide support for wooden runners for point gauge • Smaller stones placed alongside and on top of larger stones • Shape of banks built up according to markers of silicone on base surface

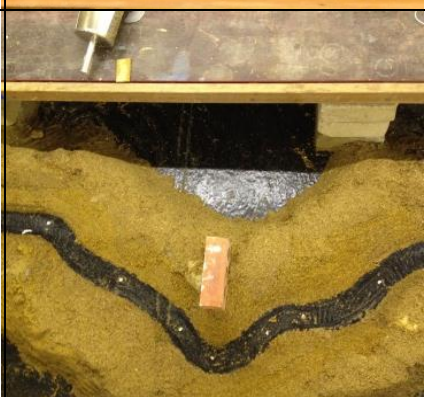
<ul style="list-style-type: none"> • Small hand held shovel used to pour sand onto the stones • Meander banks formed and compacted by hand • Damp sand used to make sure the profile was held in place

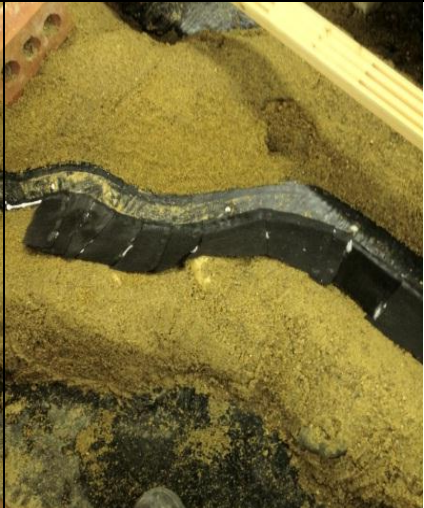
Meandering Channel – Set up	<ul style="list-style-type: none"> • Geotextile used to cover each individual bank • Base of the channel left uncovered • Geotextile cut into smaller pieces in order to follow the curves of the channel without leaving gaps • Geotextile secured in place by silicone sealant

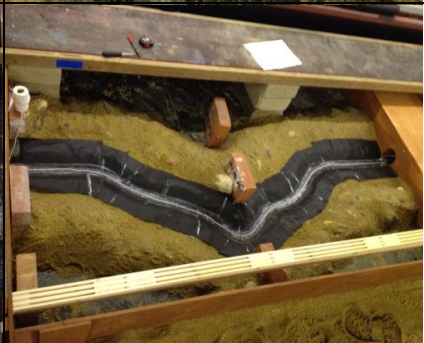
<ul style="list-style-type: none"> • Additional brick columns put in place to allow for multiple positions for the point gauge in accordance with the meander profile

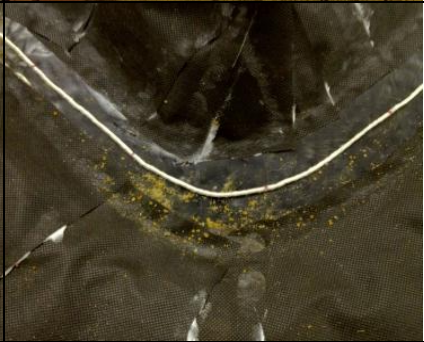
<ul style="list-style-type: none"> • String marked at 10cm intervals • String laid out following the flow path of the channel

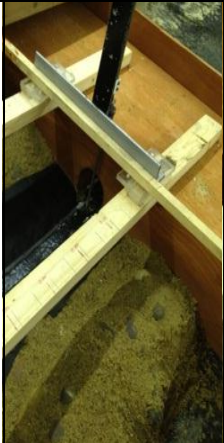
<ul style="list-style-type: none"> • Point gauge positioned at each mark on the string • Using a straight rod, measurements were marked on the outer wall • River chainage and equivalent linear distance marked for comparison with straight channel

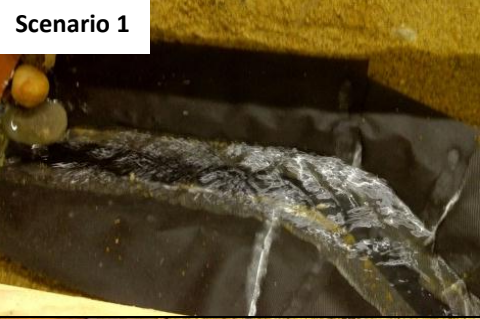
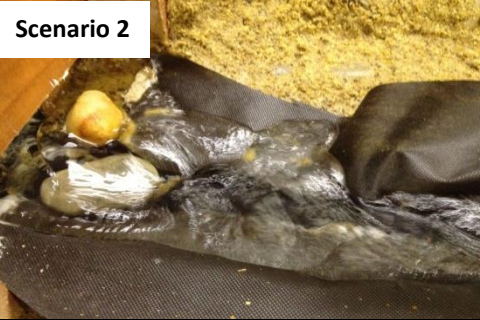
Channel inlet	<ul style="list-style-type: none"> Initially small amount of turbulence In Scenario 2 the force of the water caused the geotextile to pull away from the bank Water undermining the geotextile and eroding sand embankment 	<div data-bbox="935 405 1417 723"> <p>Scenario 1</p>

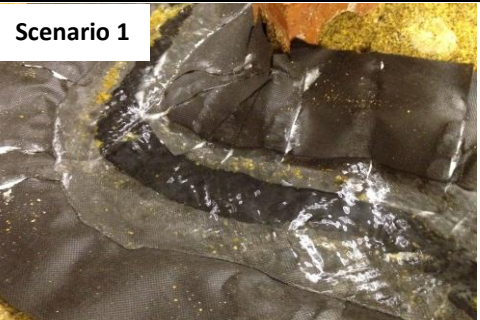
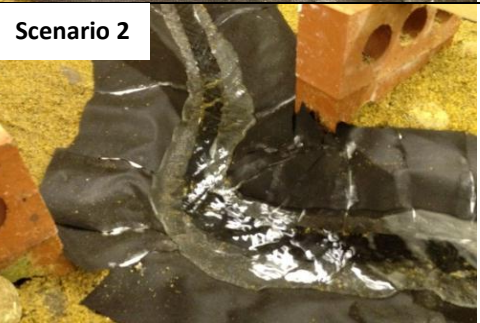
</div>
Midchannel meander	<ul style="list-style-type: none"> Water slowing as it went around main meander As discharge was increased the depth of water increased notably Banks of the channel model almost overtopped in Scenario 2 	<div data-bbox="935 1041 1417 1359"> <p>Scenario 1</p>

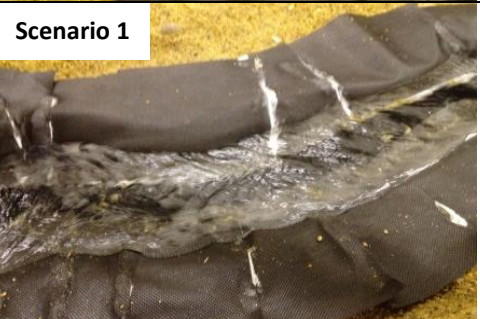
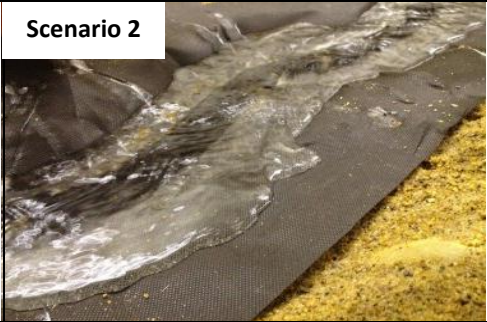
</div>
Last meander	<ul style="list-style-type: none"> Increased depth with greater discharge More turbulence visible as discharge increased The banks were almost at the 	<div data-bbox="935 1680 1417 1998"> <p>Scenario 1</p>

point of overtopping for Scenario 2

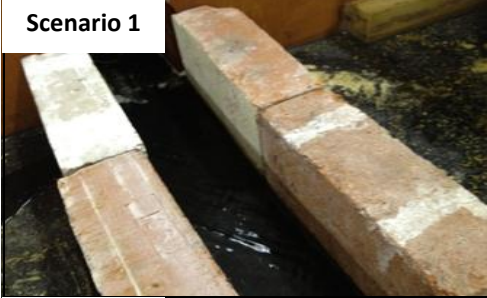
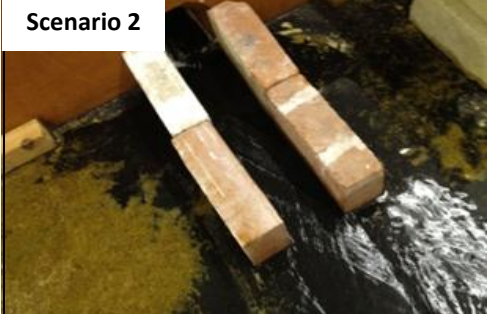
<p>Scenario 2</p>
Culvert outfall	<ul style="list-style-type: none"> • Similar water behaviour for both Scenario 1 and 2 at the culvert outfall • Slightly increased amount of turbulence in the water as discharge increased • No hydraulic jump visible for each Scenario • Outlet controlled flow as shown by Table 2

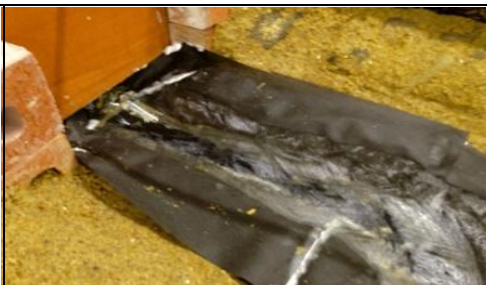
Improvements	<ul style="list-style-type: none"> • Geotextile fixed more securely at the channel inlet • Additional strips of geotextile used to fix on outside of inlet

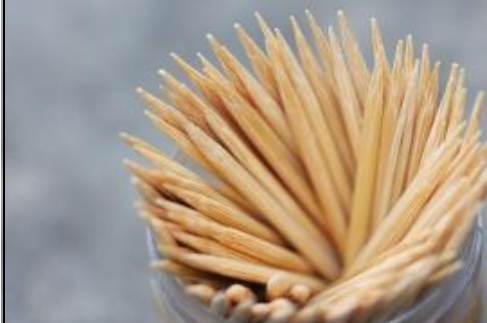
Change in method	<ul style="list-style-type: none"> • Point gauge not efficient to take depth readings • Cocktail sticks dipped at regular intervals and marked with pen to be later measured

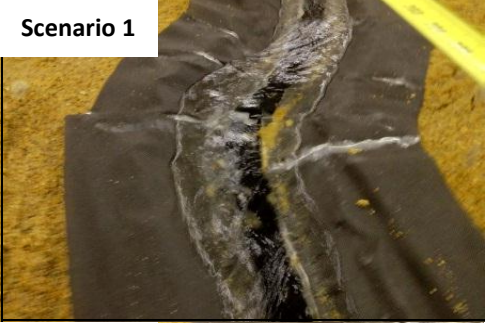
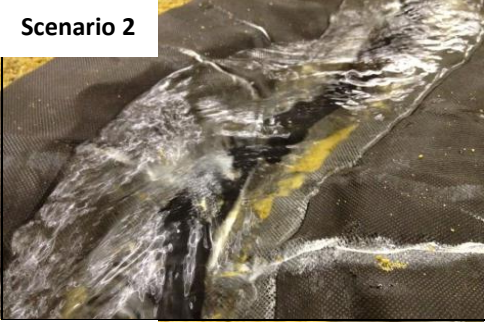
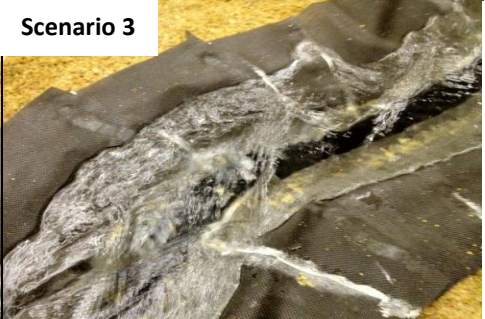
First meander	<ul style="list-style-type: none"> • Increased depth with higher discharge • Turbulence also increased with the discharge • For Scenario 3 the water was almost at the point of overtopping the banks of the channel 	<p>Scenario 1</p>

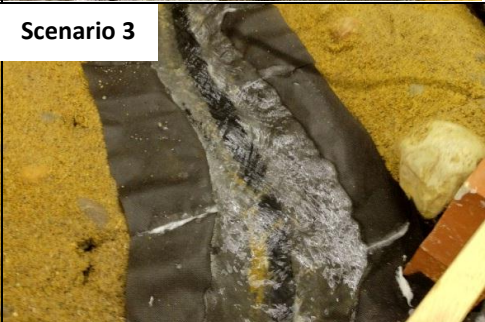
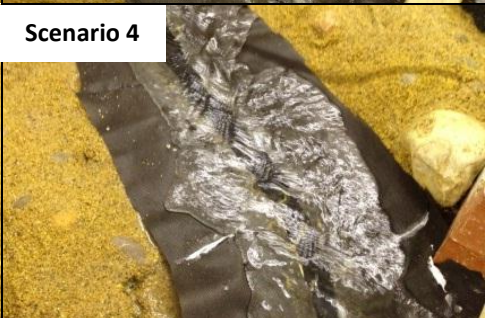
Before main meander	<ul style="list-style-type: none"> • Depth increased with great discharge • By the time Scenario 4 was in effect, the banks had been overtopped • Overtopping occurred on the outside of bends 	<p>Scenario 3</p>

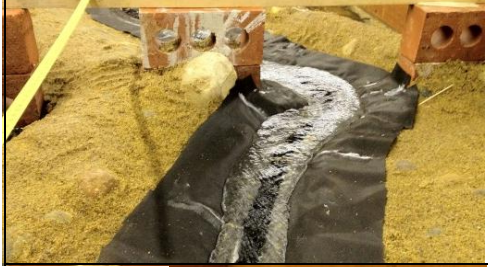
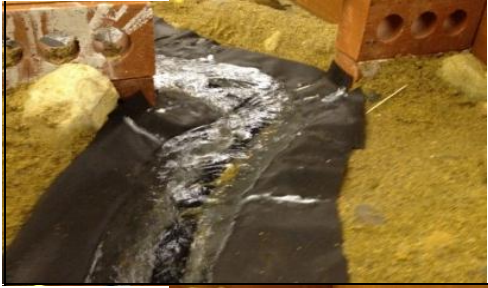
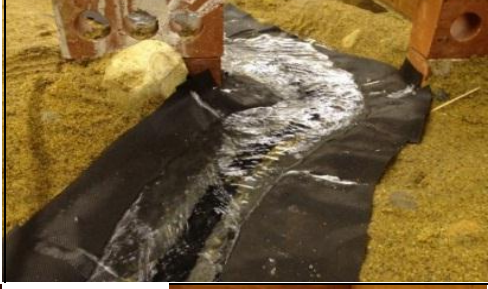
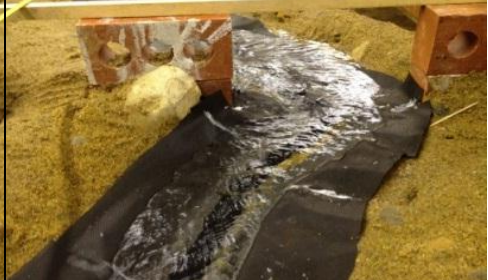
Midchannel meander	<ul style="list-style-type: none"> • Water depth increased greatly with more discharge • Flow more turbulent with higher discharge • For Scenario 3 the water was close to going over the banks • Banks on the outside of the main meander were overtopped in Scenario 4 	<div data-bbox="927 230 1417 551"> <p>Scenario 1</p>

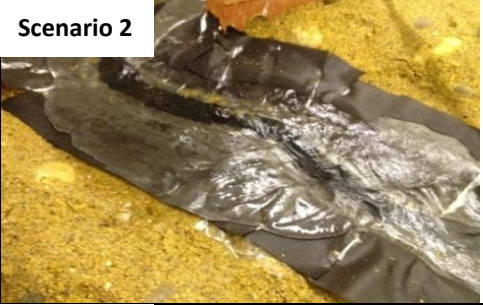
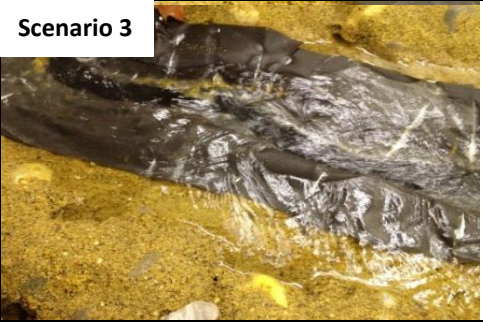
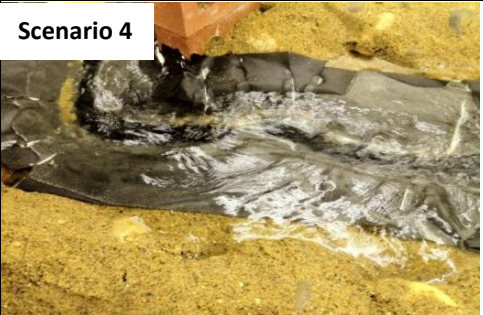
<p>Scenario 3 and 4</p> <ul style="list-style-type: none"> • Even in Scenario 2 the water is almost too much for the channel capacity • Sand quickly eroded by water when beyond the geotextile 	<p>Scenario 2</p>

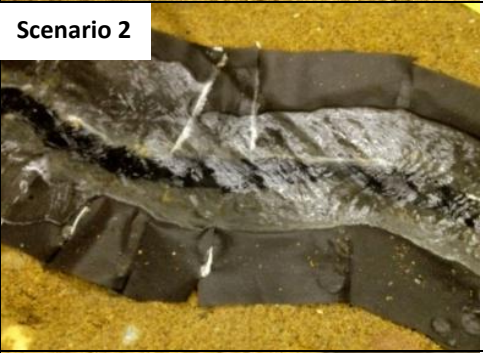
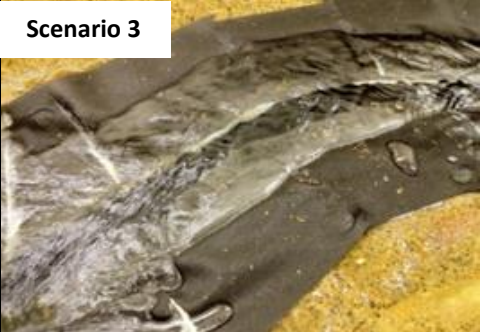
<p>Last meander</p>	<ul style="list-style-type: none"> • Water flowed more quickly beyond main meander • Water depth and turbulence increased with the higher discharges • Water not overtopping banks of channel but closer on the outside of curves 	<p>Scenario 2</p>

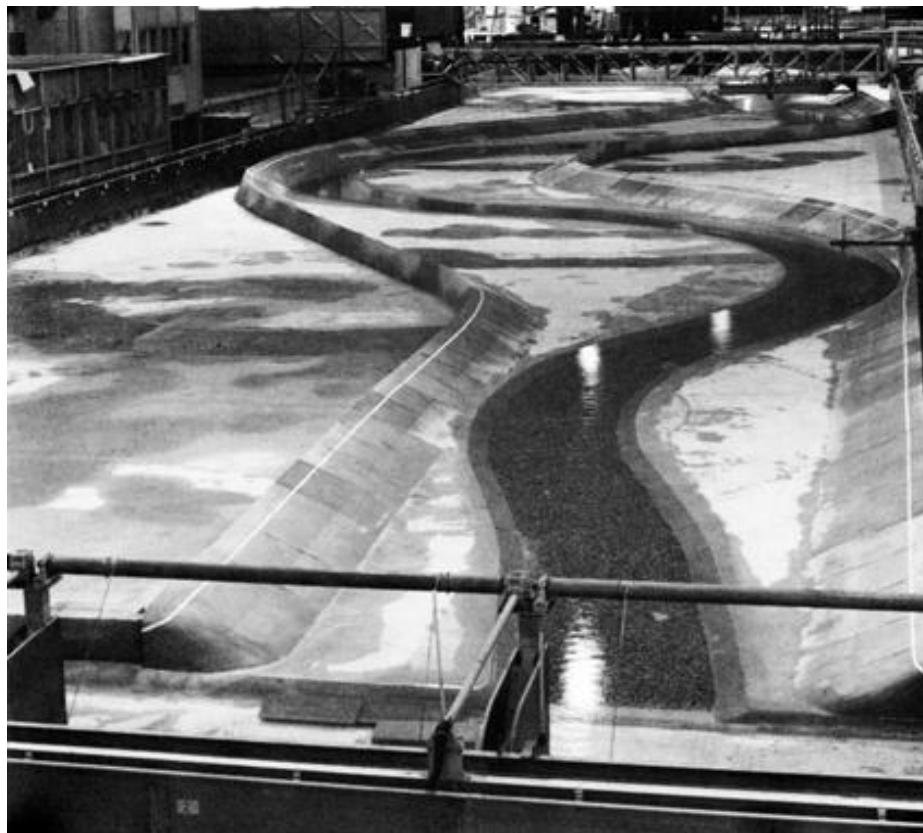
Figure 1. The River Blackwater physical model.

Only brief details of the 1:5 scale physical model is given here; a full description of the experimental set up has been described by Lambert and Sellin (1996). The undistorted 1:5 scale model of the River Blackwater was constructed in the 56 m long and 10 m wide UK Flood Channel Facility flume, as shown in Figure 1. The detail of the channel geometry and the location of the cross sections (sections 3, 4 and 5) where flow field measurements were taken, are illustrated in Figures 2 and 3. The channel surfaces were composed of smooth cement mortar. The main channel had a sinuosity of 1.18, whilst the flood channel had a sinuosity of 1.06. The longitudinal valley slope was 1×10^{-3} . The shape of the main channel cross-section was trapezoidal as shown in Figure 3. The main channel bank slopes were 45o with a bank-full depth of 150 mm. Experiments were carried out with different roughness conditions. The roughened main channel and floodplain surfaces were obtained by placing a layer of gravel on the smooth channel surfaces. The inclined walls were left smooth for all experimental runs. The floodplains were either horizontal or at an inclination of 1 in 30 (Figure 3). Only horizontal floodplain cases are considered in this study.
