The River Adur

Knepp Estate

A Survey to Assess the Current Condition

Version 1.1 (May 2016)

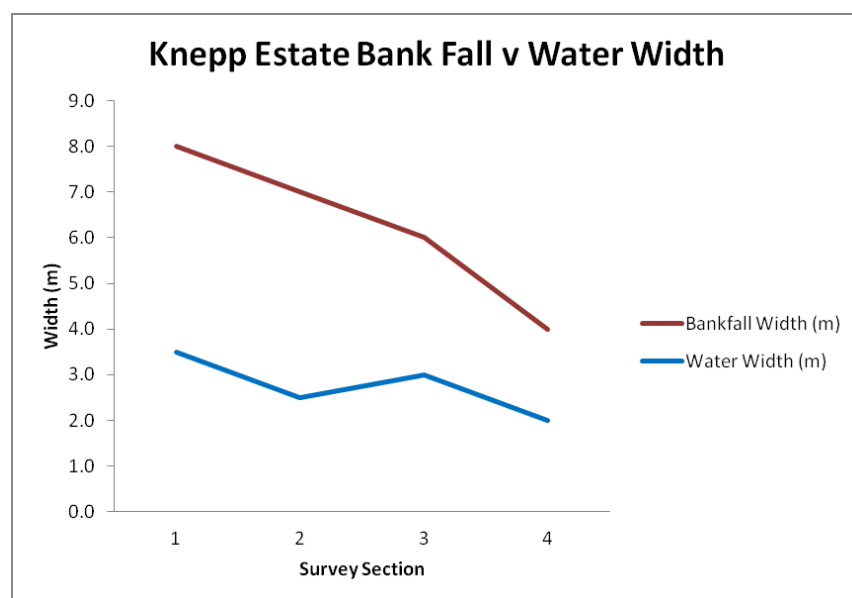
During the period of data collection the mean water depth within the channel was recorded as 0.47m (range 0.3m – 0.6m). In three of the four surveys the mean bank heights for both banks were recorded as being equal with section one showing the left bank to be, on average, 0.5m higher than the right. The mean bank fall width for the watercourse was recorded as 6.3m (range 4.0 – 8.0m) with the mean water width during the survey period being 2.75m (range 2.0m – 3.5m). The water width was recorded as being, on average, 40% of the bank fall width with considerable variation shown within each survey section. From the results it can be inferred that the channel is not trapezoidal for most of its length and a minimal amount of undercutting is occurring along the banks (the lines in Fig. 2 do not cross at any point) with the decreasing bankfall width through sections three and four representing the recently constructed river channel.

Fig. 2. The relationship between bank fall and water widths on the River Adur at the Knepp Estate.

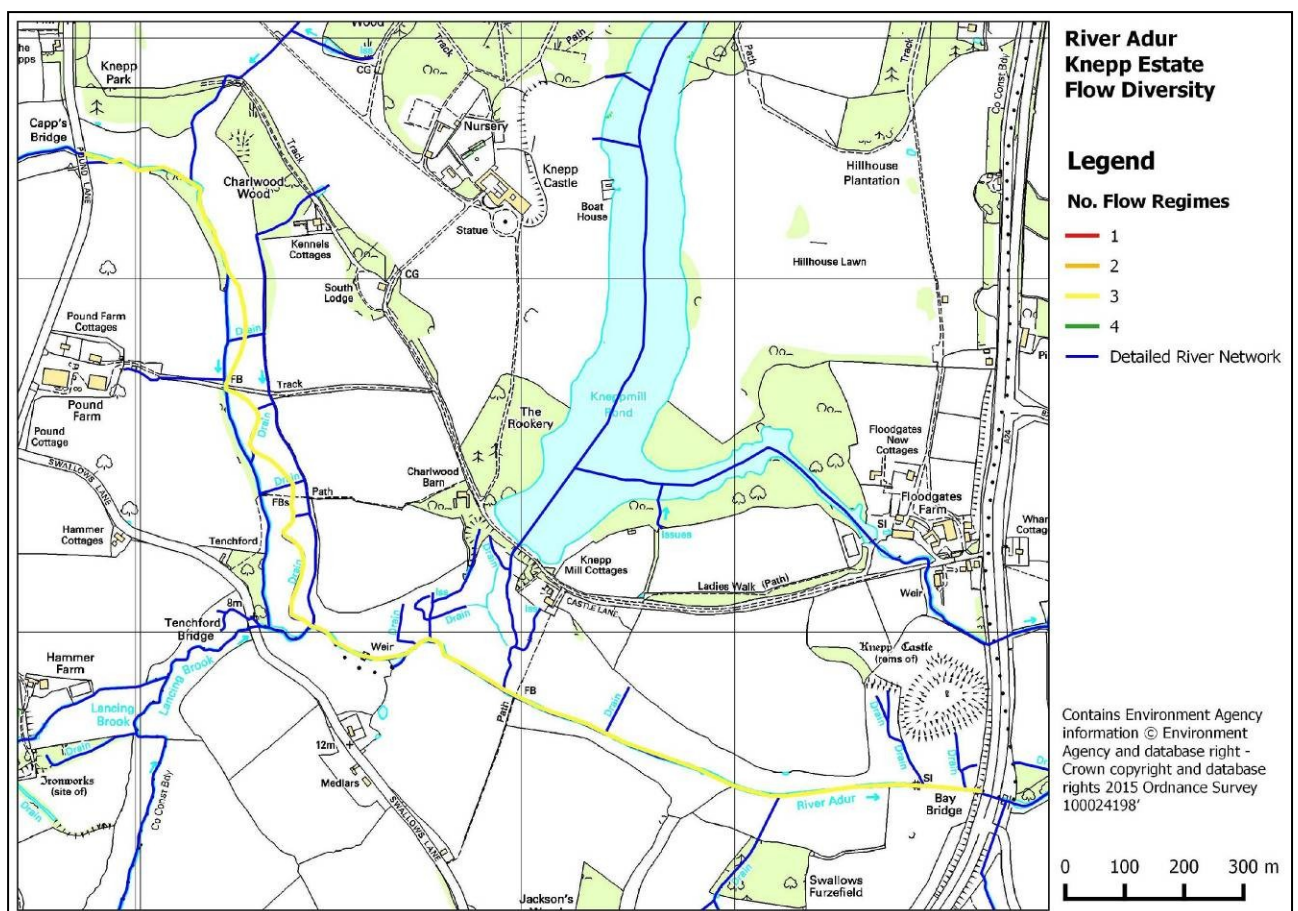
Across the survey area a total of three flow regimes were observed with 55% being recorded as having no perceptible flow, 32.5% as smooth and 12.5% as rippled (associated with glides) (Fig. 3). The number of flow regimes as an indication of diversity within each section is shown in Fig. 4. Only section one was recorded as having a >33% impoundment within it which is likely to be a result of the A24 bridge culvert and presence of Bay Bridge weir.

Fig. 4. Number of flows, as an indication of flow diversity, within each survey section of the Knepp Estate.

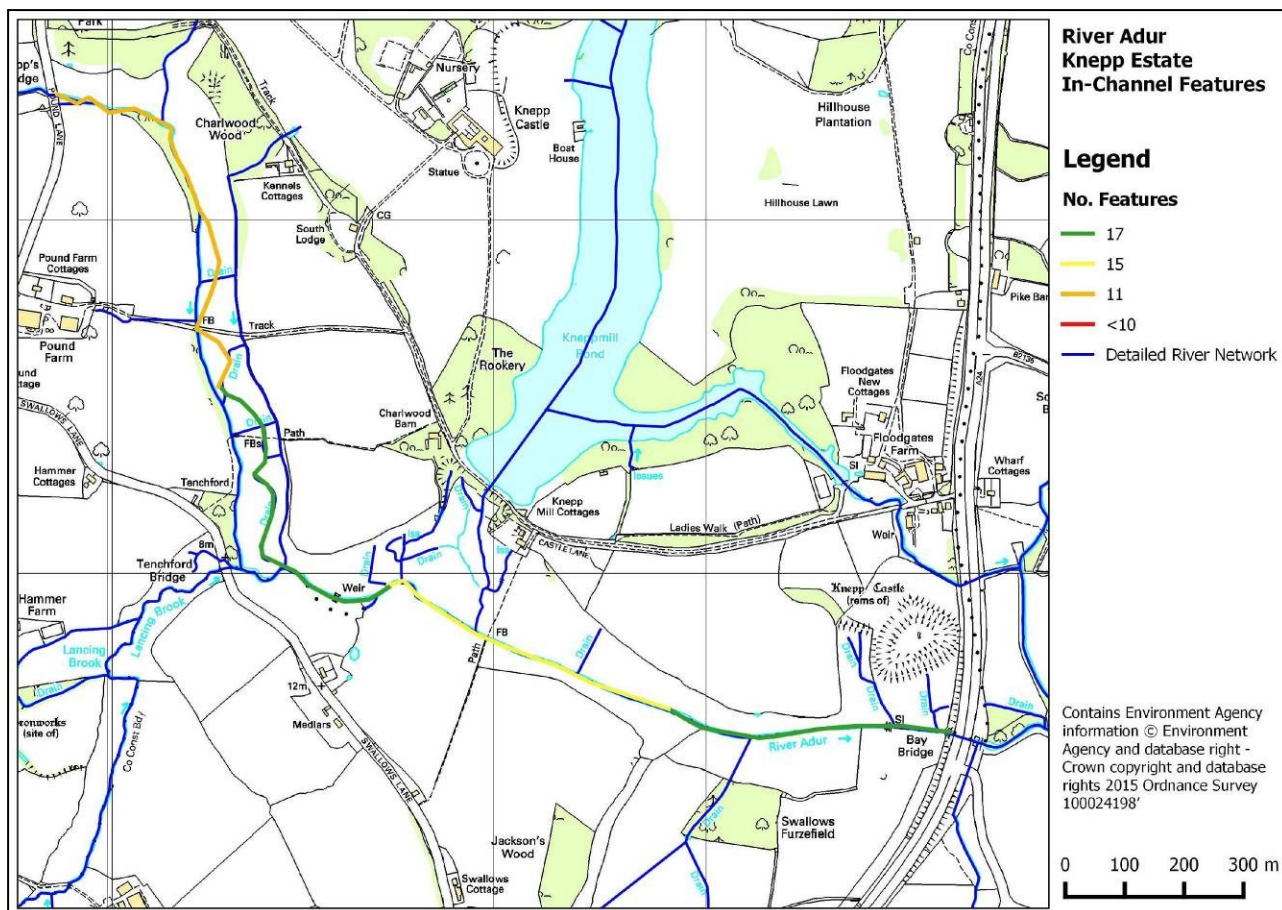
A total of 60 in-channel features were recorded across six categories (riffles, berms, side bars, point bars, mid-channel islands and large woody debris) (Fig. 7). This gives an average of 12.5 features per survey section or, on average, one feature every 33m for the course of the river. The presence of riffles was recorded in one of the survey sections.

The highest number of features observed in any one survey section was 17 (sections 1 and 3). Whilst section three has been enhanced through the creation of a new channel and the introduction of a number of woody features, the features in section one appear to be occurring naturally through bank slumping as a result of the removal of the weir boards at Bay Bridge. Large woody debris was recorded at four locations along the length of the stream mainly concentrated in the central area (Fig. 8).

Fig. 7. Number of features per survey section on the River Adur as it flows through the Knepp Estate.

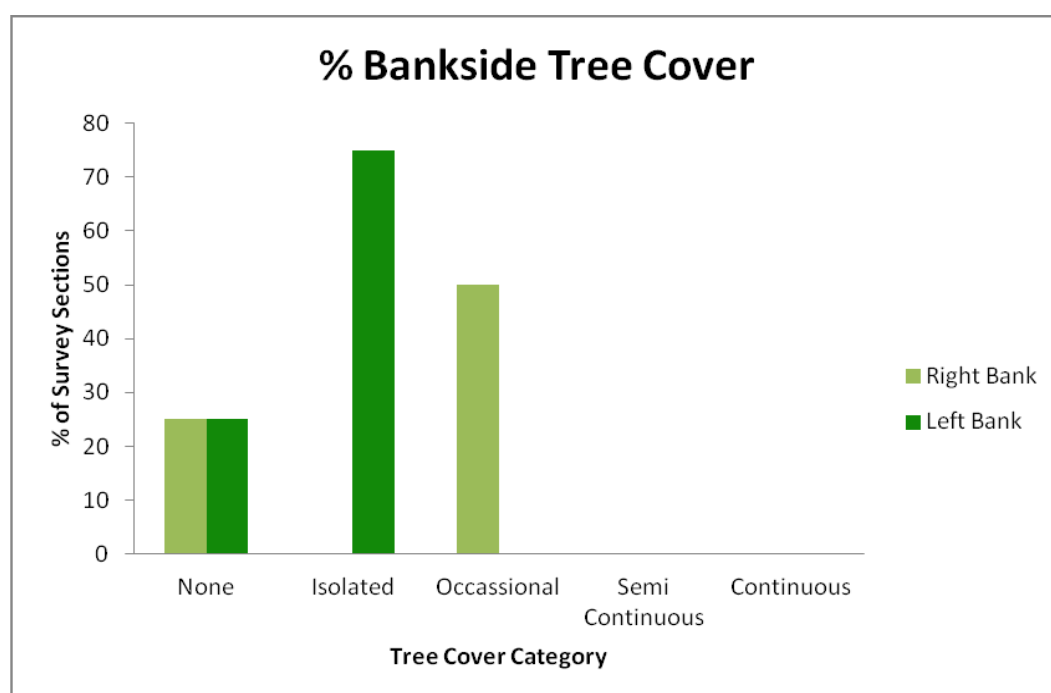
The river survey has shown an absence of continuous or semi-continuous bankside tree cover through any survey section. Isolated tree cover was recorded across 50% of the survey area (when both banks are considered together), with occasional at 25% and no tree cover at 25% (Fig. 9).

Fig. 9. Percentage bank side tree cover for left and right banks.

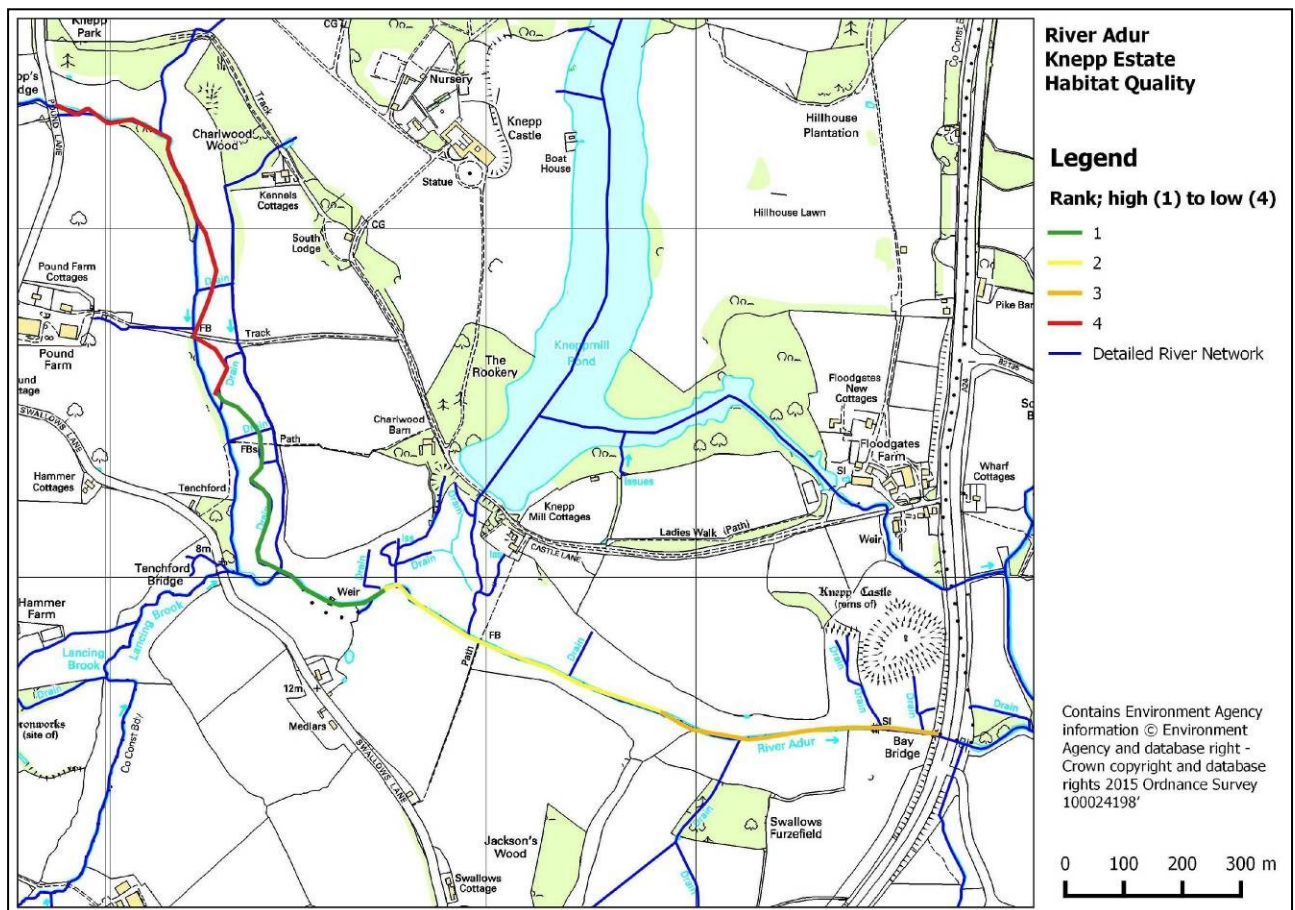
The Habitat Quality Scores (HQS) for the watercourse ranged from 32 to 45 with an average of 38. This indicates limited variation in habitat quality across the survey area. The highest scoring area is within the newly constructed river channel where a number of in-channel features, such as berms and deflectors, have been installed. Interestingly the fourth survey section also incorporated parts of the new channel which had also seen features installed but less frequently and many of these will take some time before providing benefits to the habitat of the river. The overall picture of riverine habitat quality for the River Adur as it flows through this section of the Knepp Estate is shown in Fig. 11. This scoring system is relative and a result of this is that there will always be sections ranked low in comparison to others regardless of the actual score received. However, with a recorded highest score of 45 (whilst categorized as high in terms of the survey, this is some way below the potential “top scores” for HQS in lowland rivers which can reach in excess of 100 (Raven *et al.*, 1998) and surveys within the Adur & Ouse catchment realising top scores of 70) it is, in this case, assumed that those areas ranked in the bottom half would benefit from immediate remedial action to improve both in-channel and bankside conditions but all sections could be further improved to maximise the riverine habitat potential.

Fig. 11. Habitat Quality Scores ranked from high (1) to low (4).

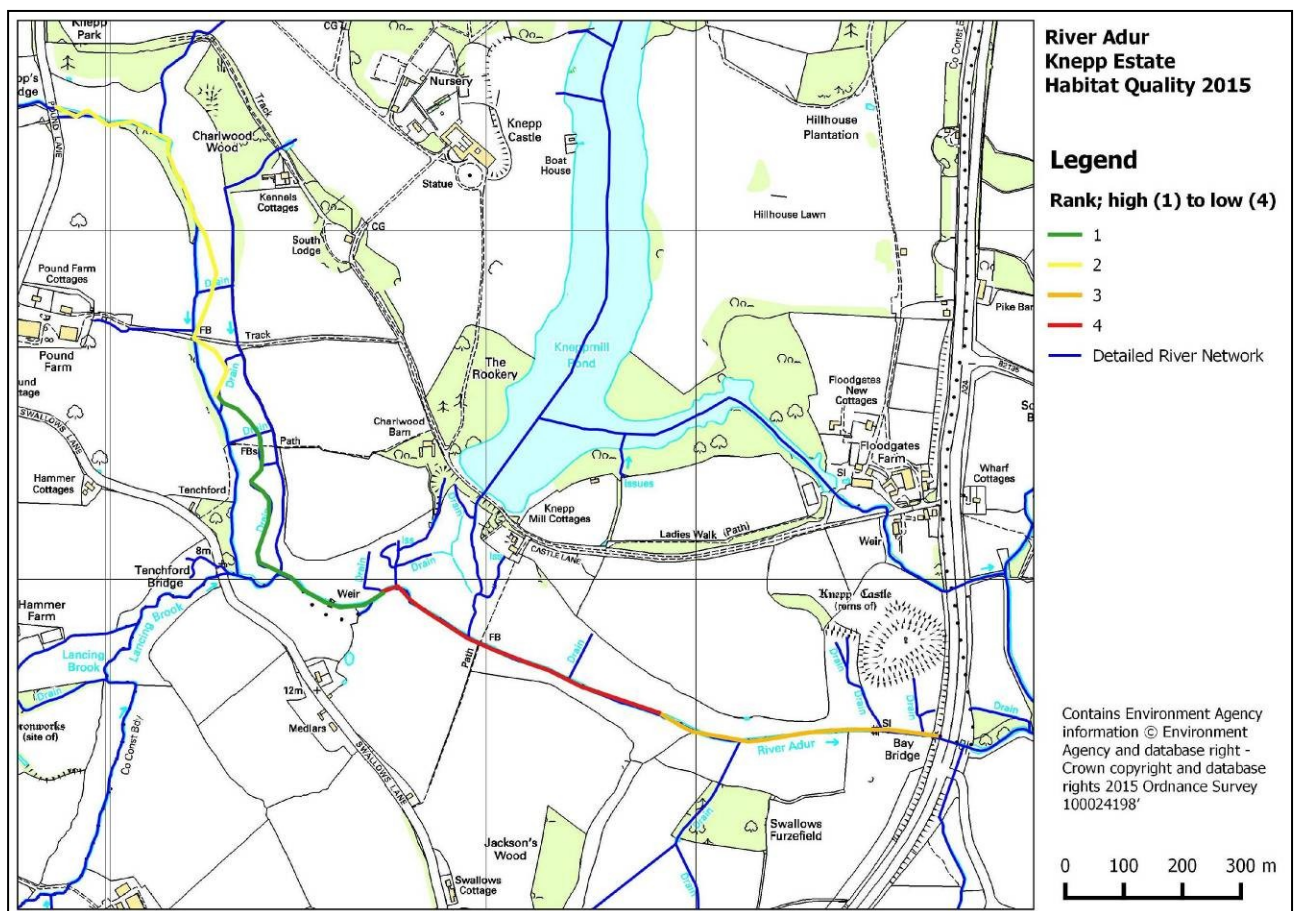
When compared against the results of the survey undertaken in May 2015 there appears to have been some alteration in survey section rankings for habitat quality (Fig. 12). In 2015 section four received the second highest score for HQS with section two being the lowest, these two sections have reversed in their ranking. This appears to be as a result of the bank vegetation structure and presence of in-channel vegetation scoring higher through section two along with the natural build up of large woody debris and higher presence of bankside tree cover within this section.

Interestingly section one has seen the largest increase in HQS despite remaining ranked third. This is likely to be the result of the removal of the boards at Bay Bridge Weir which is allowing natural river processes to form sinuosity, increased flow dynamics, in-channel vegetation and a number of in-channel features.

Fig. 12. Habitat Quality Scores from May 2015 ranked from high (1) to low (4).

These scores may, however, be biased by flow conditions and river levels at the time of survey which may drown out features which are present but not visible. As such further repeat surveys are recommended on an annual basis to assess changes to the river system over a longer period of time.

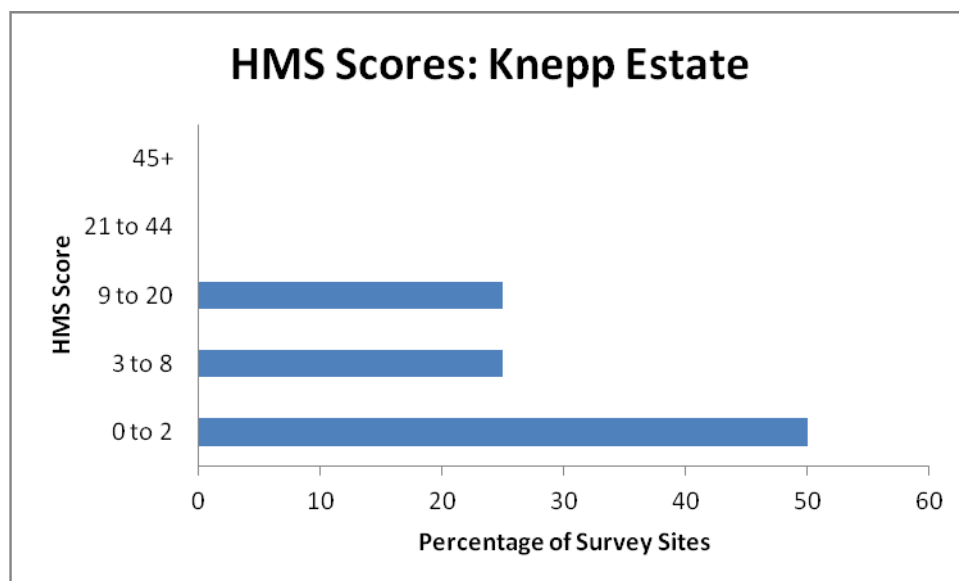
Habitat Modification Scores (HMS) were calculated for each survey section using guidance in Raven *et al*, (1998). Scores within the sub-catchment ranged from zero to 13. The watercourse is shown to be obviously modified (range, 9-20) within 25% (equal to one) of the survey sections, which is a result of the A24 road culvert and Bay Bridge Weir within section 1 (Fig. 13). Whilst there has been a large scale river restoration project undertaken on the site which has seen two weirs removed and the channel re-directed these have not been classed as modifications as the purpose has been to restore the river to its natural functioning condition.

Fig. 13. Habitat Modification Score ranges as a percentage of sites surveyed.

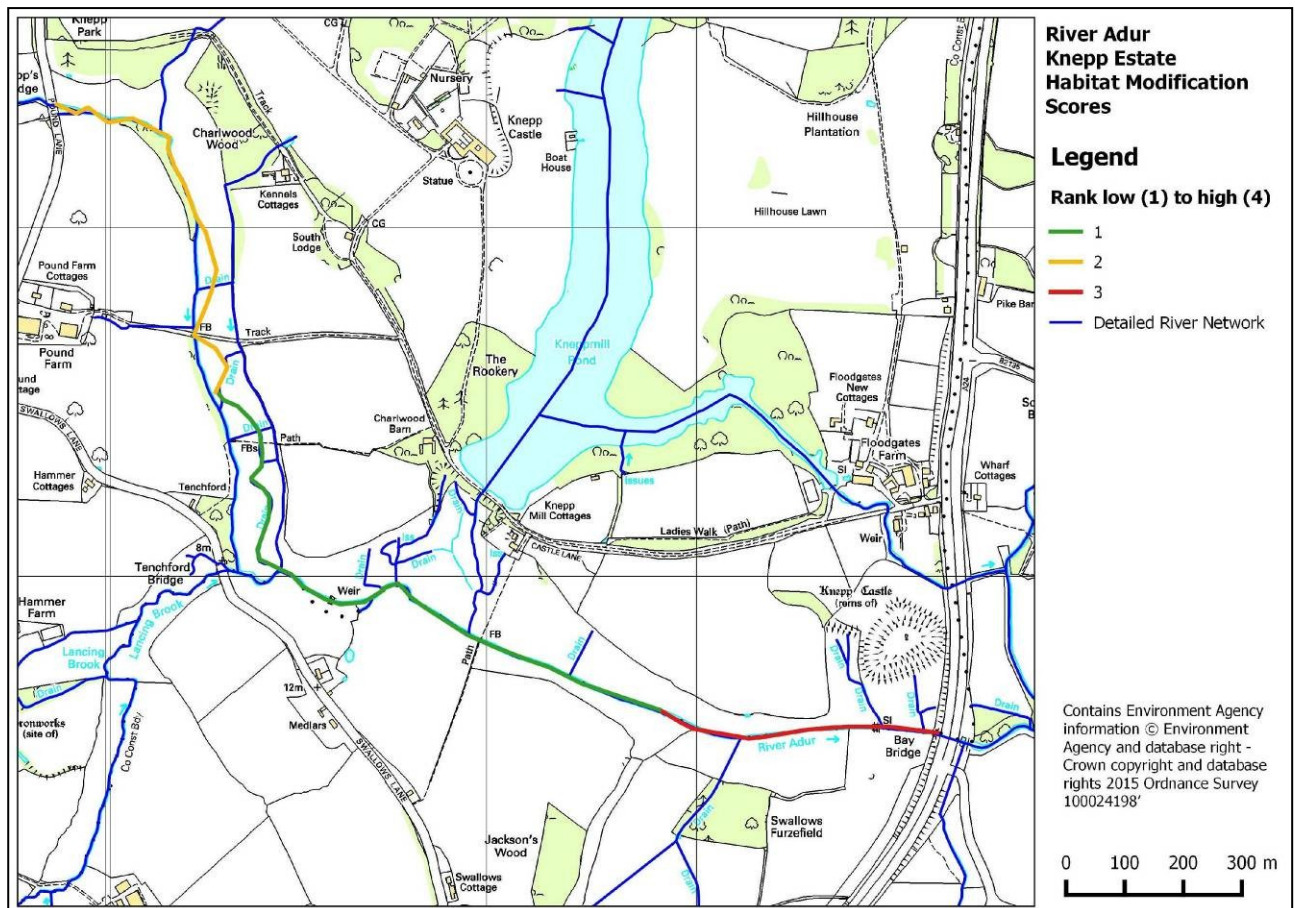
HMS scores have been ranked and entered into a GIS format to indicate those areas which have undergone the greatest/least amount of modification (Fig. 14). The HMS rankings, as would be expected, have not changed since the last survey in May 2015.

Fig. 14. Habitat Modification Scores ranked from least modified (1) to most modified (3).
